**DEPARTMENT OF TRANSPORTATION****DIVISION OF ENGINEERING SERVICES**

Contract #: 04-0120F4Cty: SF/ALA Rte: 80 PM: 13.2/13.9File #: 69.28**WELDING INSPECTION REPORT****Resident Engineer:** Pursell, Gary**Address:** 333 Burma Road**City:** Oakland, CA 94607**Report No:** WIR-001198**Date Inspected:** 07-Jan-2008**Project Name:** SAS Superstructure**OSM Arrival Time:** 830**Prime Contractor:** American Bridge/Fluor Enterprises, a JV**OSM Departure Time:** 1730**Contractor:** Zhenhua Port Machinery Company, Ltd (ZPMC), Changxing Island **Location:** Shanghai, China**CWI Name:** See Below**CWI Present:** Yes No**Inspected CWI report:** Yes No N/A**Rod Oven in Use:** Yes No N/A**Electrode to specification:** Yes No N/A**Weld Procedures Followed:** Yes No N/A**Qualified Welders:** Yes No N/A**Verified Joint Fit-up:** Yes No N/A**Approved Drawings:** Yes No N/A**Approved WPS:** Yes No N/A**Delayed / Cancelled:** Yes No N/A**Bridge No:** 34-0006**Component:** Tower and OBG Fabrication**Summary of Items Observed:**

Orthotropic Box Girder (OBG) and Tower Mock Up:

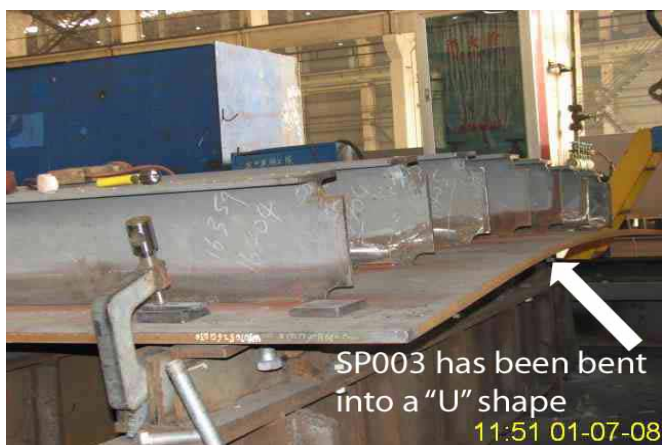
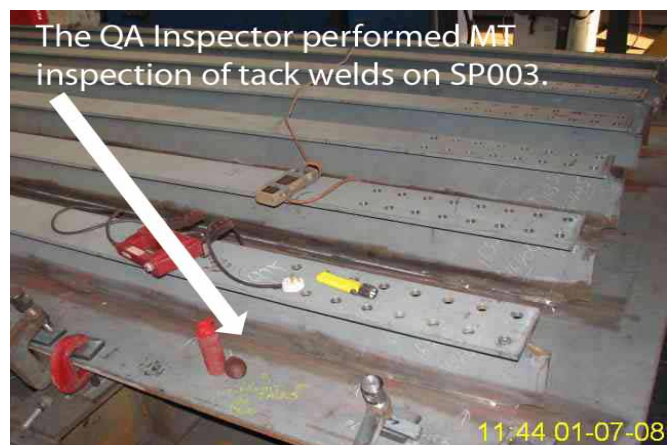
The QA Inspector performed random visual inspections and magnetic particle inspections of portions of OBG PL73B side plate SP013 stiffener fillet tack welds BP013-01-030 through BP013-01-043. The plates are being placed on a pre-camber table in order to minimize weld distortion. A heavy weight had been placed in various locations on the side plate prior to clamping of the edges of the plate. Items observed by the QA Inspector appear to comply with project specifications. See the photographs below for additional information.
